# CONSTRUCTION COMPLETION REPORT

## MIRROR LAKE DOVER, DELAWARE

March 2014

## **MIRROR LAKE REMEDIATION AND RESTORATION**

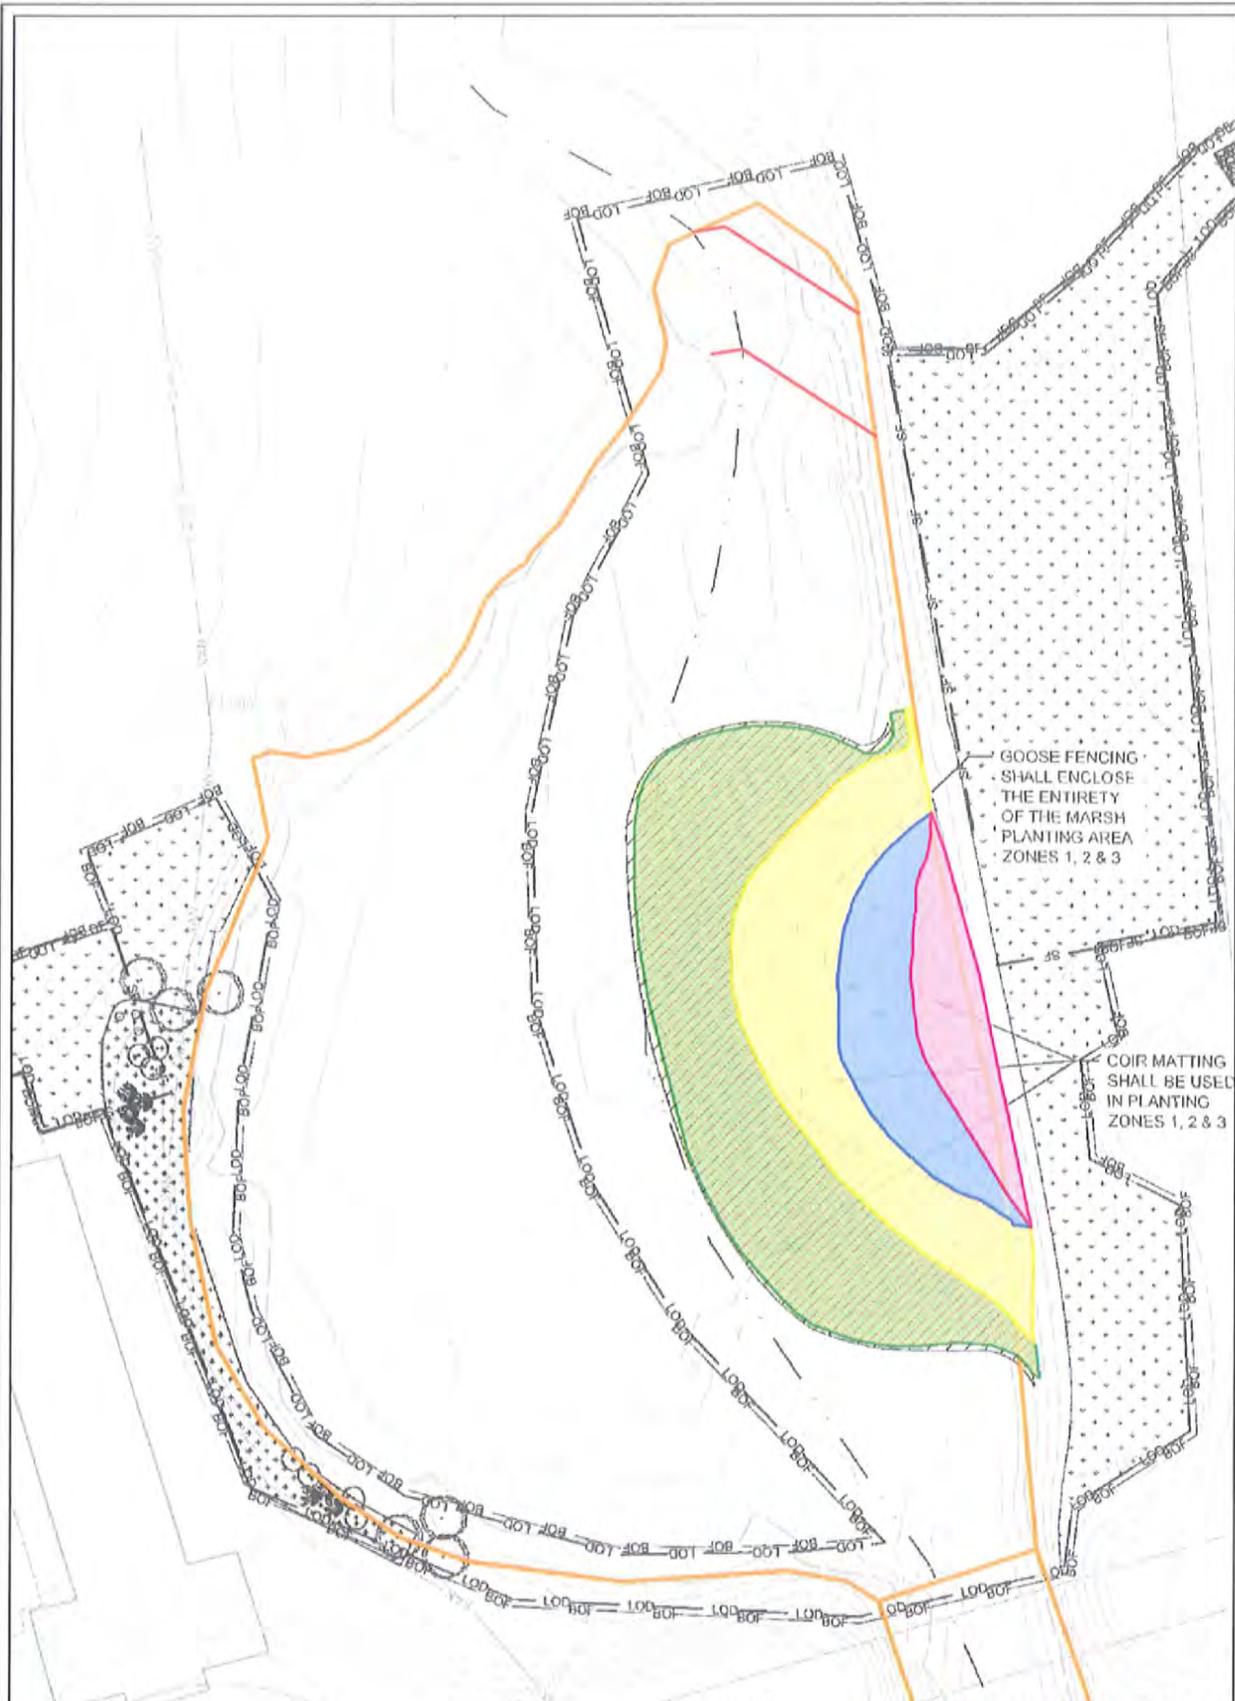
## **FIGURE 2**

# **Intertidal Wetland As-Built**

- Rock Vane
- Intertidal Wetland Not Installed
- Zone 1 Planning
- Zone 2 Planning
- Zone 3 Planning
- Site Boundary

The wetlands are being planted in 5 separate zones. Zone 1 was successfully planted and matted in early November 2013 to ensure the structural integrity of the toe of the intertidal wetland along the channel. Zones 2, 3, 4, and 5 were not needed for structural support and will be

planted in Spring 2014 once the weather is suitable for good growth (Fig. 2). The west bank was reinforced by placing two stacked 16 inch diameter coir logs along the bank and placing mulch in the voids between the coir logs and the bank. In total, about 400 linear feet of shoreline were stabilized through coir log placement. All of the restoration methods help to reduce erosion and enhance the natural beauty of Mirror Lake.

SediMite™ was spread using the telebelt, induction air horn, Vortex spreaders, and by hand. The telebelt was on site for 5 full 8 hour days, including two days of down time due to a broken cable on the extension arm. It was the most efficient method of application and was able to broadcast approximately 40 tons of SediMite™ during the 3 operational days on the east and west sides. The telebelt was also used to place all of the sand used for the intertidal wetland restoration. The induction air horns were used on land and in the boats to evenly spread the SediMite™ along the banks of the lake as well as in the areas which were not accessible with the telebelt (e.g. under overhanging trees). Transect lines and 20 foot by 20 foot grids were used to mark application areas. Induction air horns were able to apply approximately 3-4 tons of SediMite™ in an 8 hour work day. SediMite™ was applied to downstream areas using Vortex spreaders, induction air horns, and by hand spreading. Hand spreading was an efficient method of application but required more boat maneuvering to uniformly spread the SediMite™ over the entire area. The Vortex spreaders were less efficient than other methods used and were cumbersome to use while on a boat. However, hand spreading and Vortex spreaders were able to spread 4-5 tons of SediMite™ in an 8 hour work day (see Figure 2).

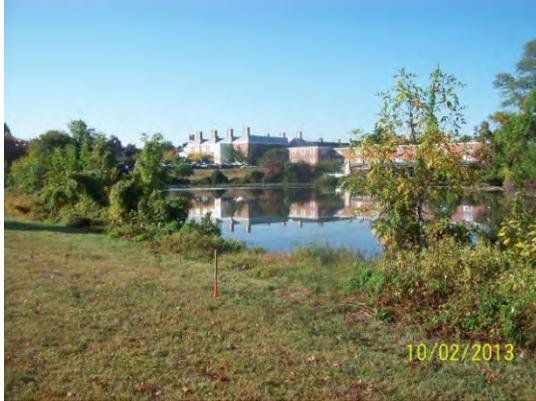
East bank of Mirror Lake prior to remediation.

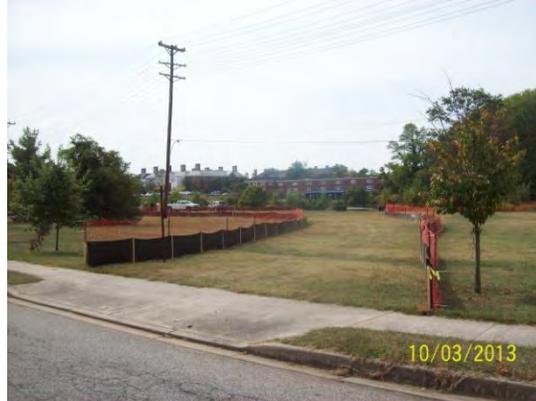
Erosion and Sediment Controls in Place.

Sediment and Erosion control methods were implemented as outlined in the plans according to the Delaware Erosion and Sediment Control Handbook prior to lake remediation and restoration work. Silt fence and orange construction fence were installed around the perimeter of all areas to be disturbed during construction activities. A stabilized construction entrance (SCE) was installed on the east and west side. Geotextile fabric was placed throughout the construction areas and covered by approximately 1 foot of mulch to provide a base for temporary construction vehicle traffic and operation, while protecting the land surface below. Turbidity curtain was installed around the perimeter of the intertidal wetlands and rock vane work area to keep sediments from traveling up or down stream.

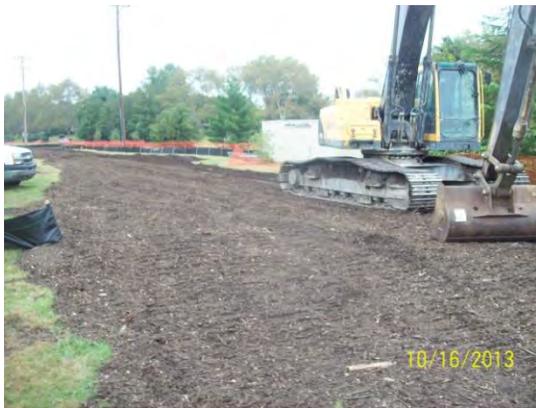
Mulch road installation.

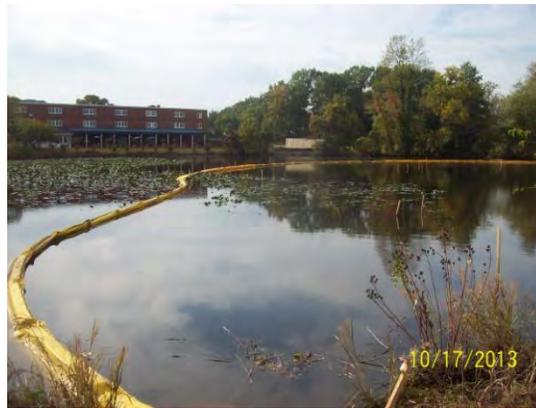
Turbidity Curtain installation.

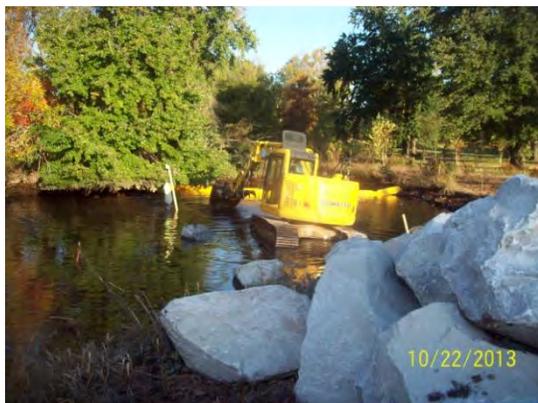
Cross Vane Installation.

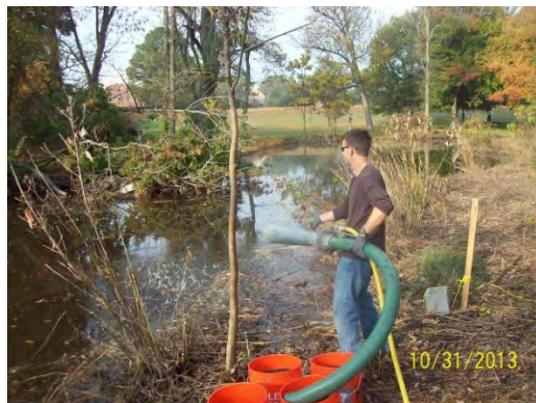
Induction air horn spreading along bank.

- The telebelt used a hopper and belt system to evenly distribute the SediMite™ over a large area in uniform rows.
- The induction air horn used compressed air to create a vacuum which could distribute the SediMite™ with an approximate range of 15 feet to 20 feet.
- Vortex spreaders used gravity fed hoppers and a leaf blower to distribute the SediMite™ over an approximate range of 10 feet to 15 feet.
- Spreading the SediMite™ by hand allowed for increased maneuverability in the boats during downstream remediation efforts.

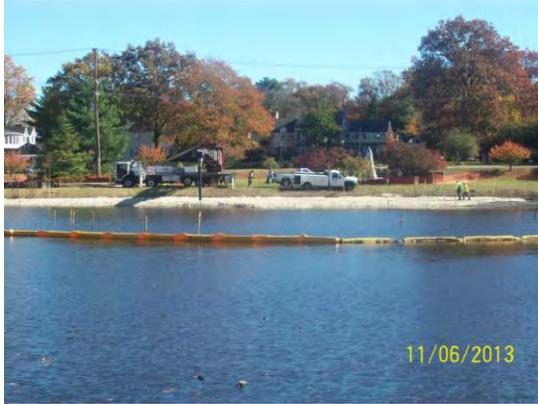
Telebelt spreading sand and SediMite™.

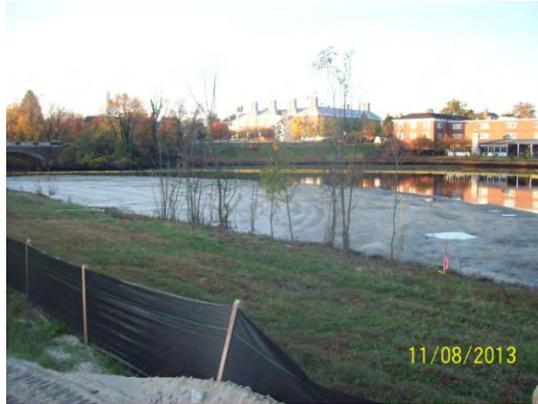
Sand bar partially completed.

- The banks along the lake and upstream areas were pruned in order to remove all invasive species and to aid in the remediation and restoration of the lake.
- The existing sandbar was enhanced to create an intertidal wetland on the east bank.
- Rock vanes were constructed upstream of the wetlands to assist in directing the natural flow of the thalweg.

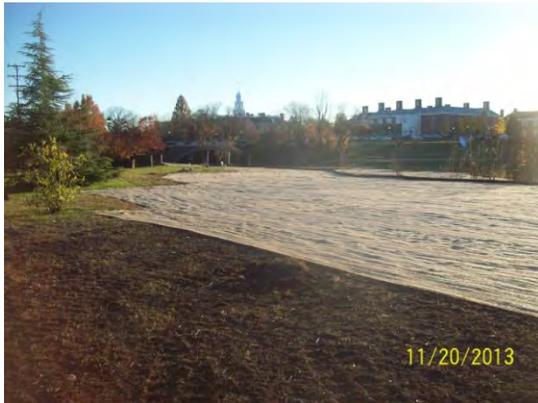
Seeding and erosion control matting.

At the completion of the remediation and restoration efforts silt fence, mulch, and stabilized construction entrances were removed upon the consent of DNREC. The disturbed areas on the east and west sides of the lake were seeded and stabilized. Stabilization was done with the use of biodegradable straw matting, compost logs, and straw waddles. Certified Construction Review (CCR) reports were started during December 2013 and will continue until 70% germination can be documented throughout the site.

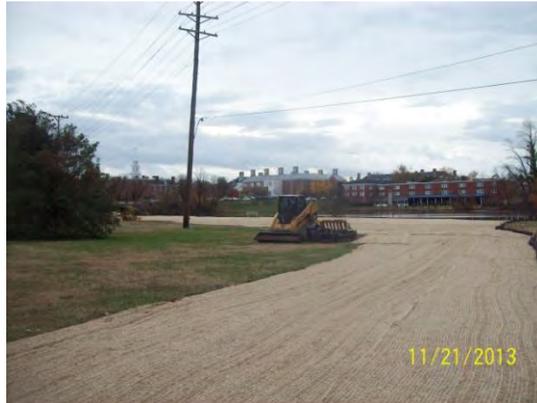
Completed restoration.

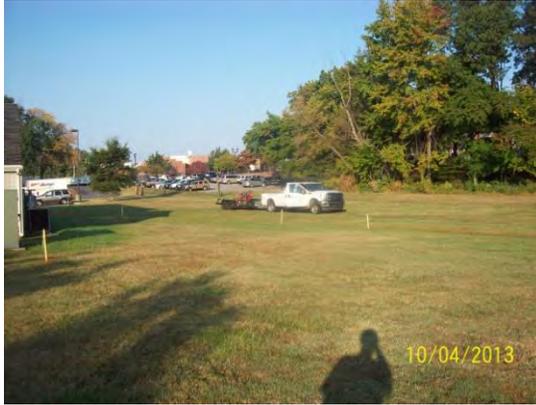
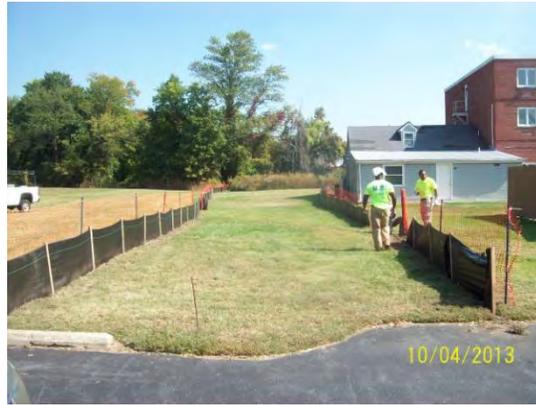
West side of Mirror Lake prior to remediation. Erosion and sediment controls in place.

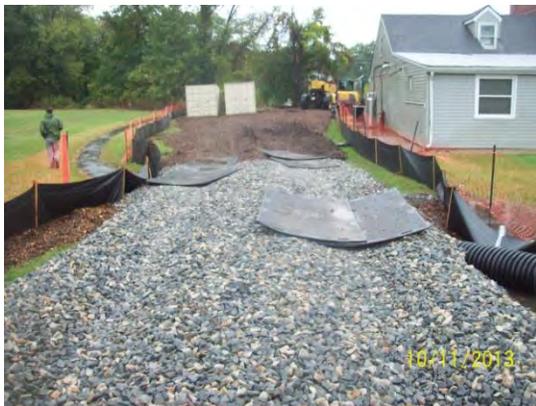
Mulch road installation.

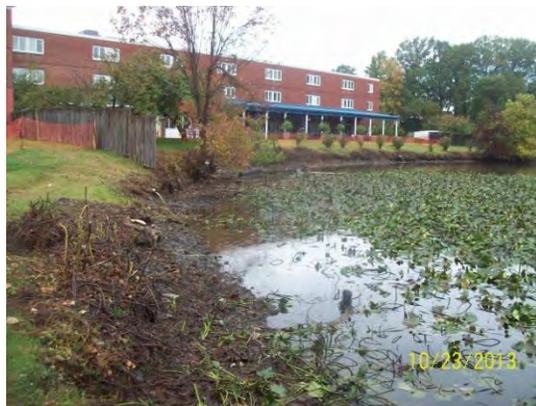
Clearing along bank.

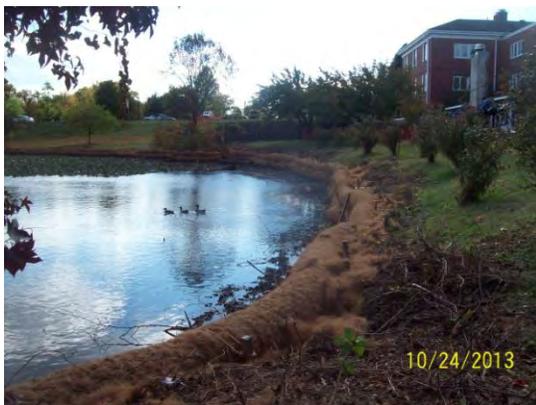
Coir log installation.

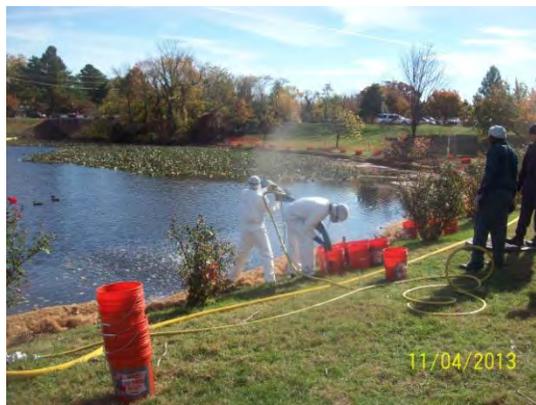
Induction air horn spreading along bank.

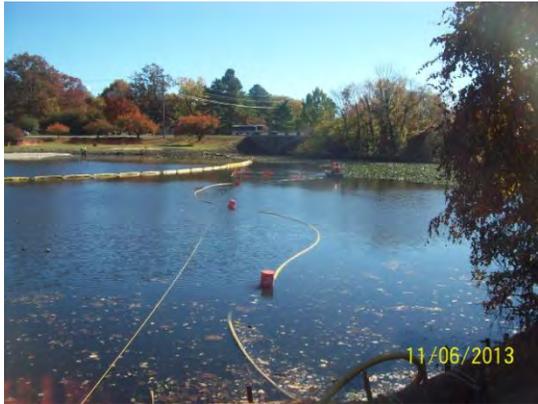
Induction air horn spreading from boat.

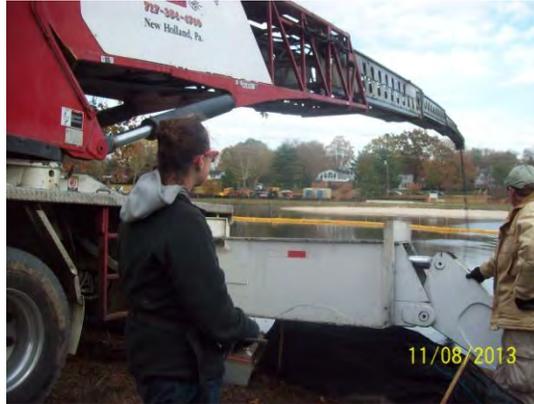
Telebelt spreading SediMite™ from west side.

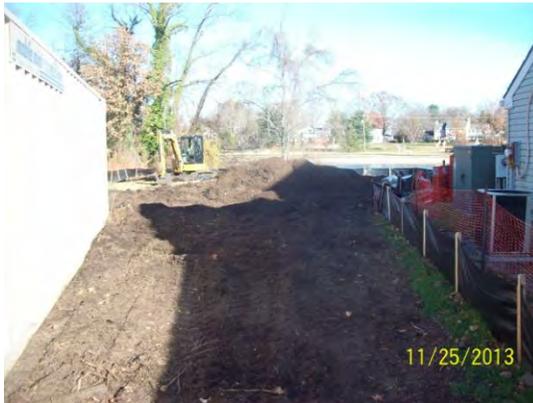
Removing mulch and grading site.

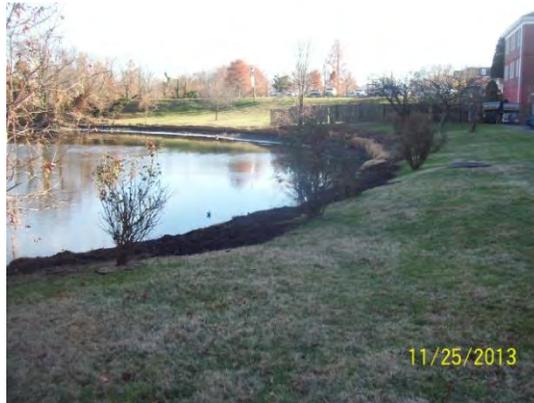
Mulch placed along bank behind coir logs.

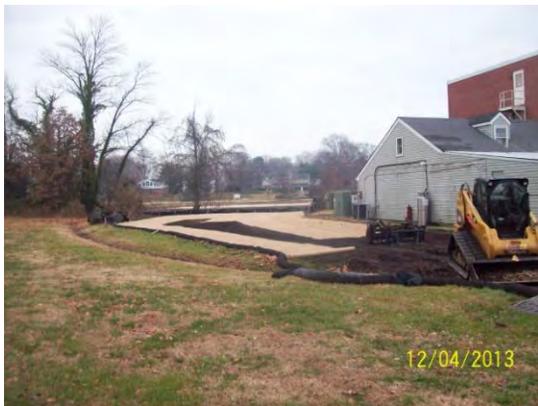
Seeding and erosion control matting.

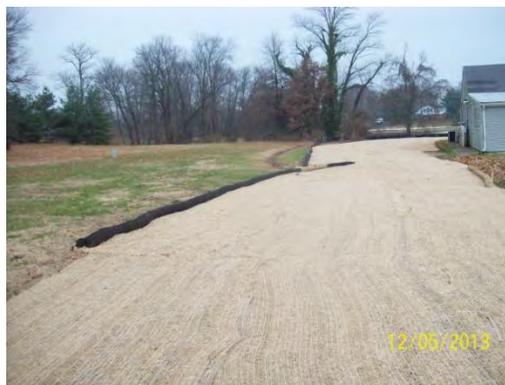
Completed restoration.
