Installing an Activated Carbon Sediment Amendment at the Puget Sound Naval Shipyard & Intermediate Maintenance Facility, Bremerton, WA

Presentation for Seventh International Conference on Remediation of Contaminated
Sediments. February 4-7, 2013, Dallas, TX

Robert K. Johnston (johnston@spawar.navy.mil), Victoria Kirtay, D. Bart Chadwick, Gunther Rosen, and Joel Guerrero (Space and Naval Warfare Systems Center Pacific, San Diego, CA); John Collins and Craig Ortega (AquaBlok Ltd, Toledo, Ohio); Robert Webb and Richard May (Dalton Olmsted & Fuglevand, Inc., Poulsbo, WA); Joe Germano, David Browning, and Ezra Beaver (Germano and Associates, Bellevue, WA); Mark Wicklein, John Pittz, and Dwight Leisle¹ (Naval Facilities Engineering Command Northwest, Bangor, WA); Lesley Doyle and Larry Hsu (Puget Sound Naval Shipyard & Intermediate Maintenance Facility, Bremerton, WA)

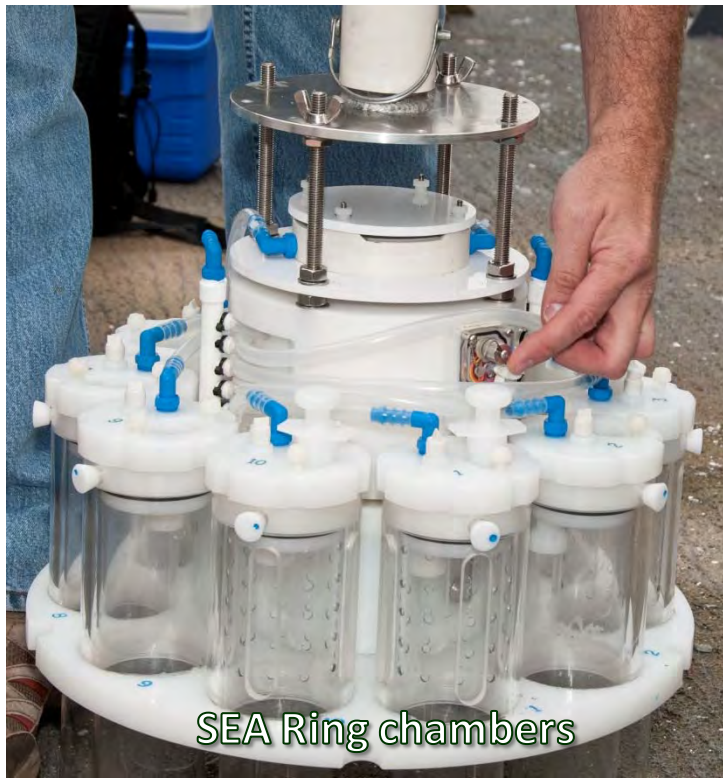
- Amendment Target Area
- SPI Monitoring
- SEA Ring Chamber
- Reference Site

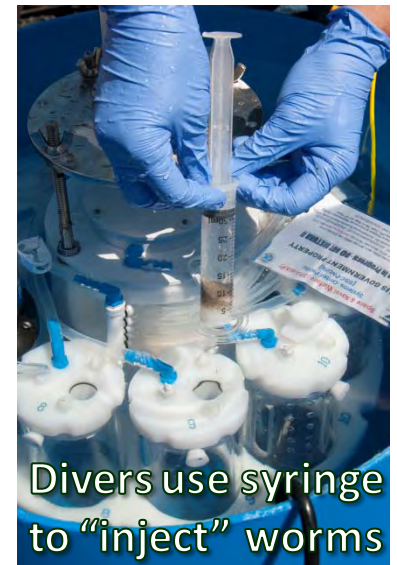
Divers use syringe to "inject" worms

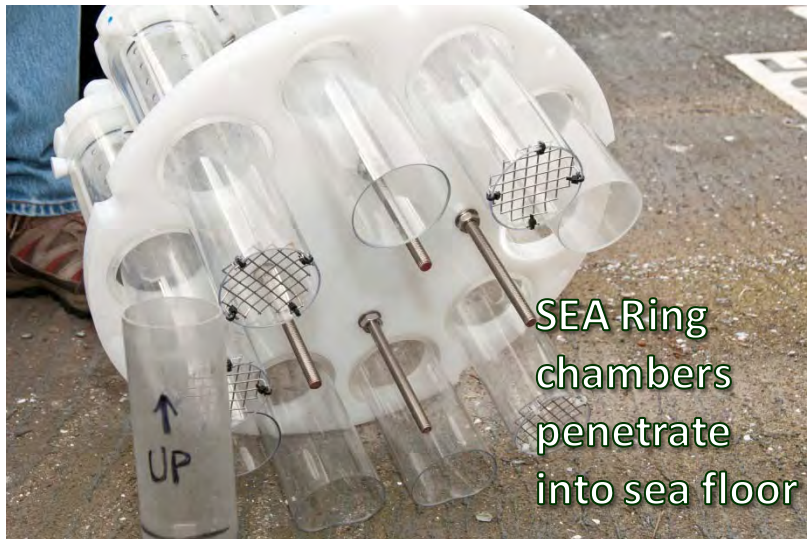
SEA Ring
chambers
penetrate
into sea floor

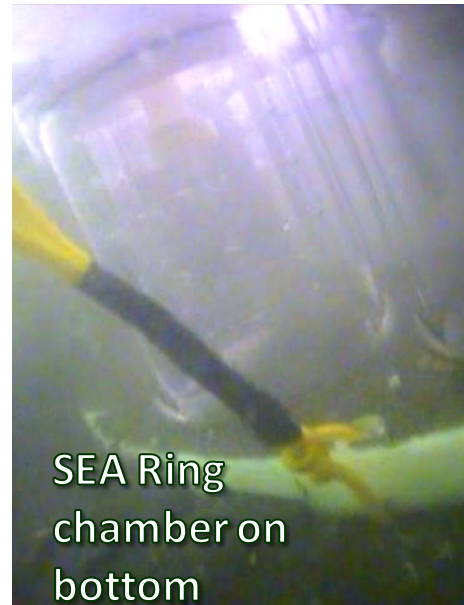
SEA Ring
chamber on
bottom

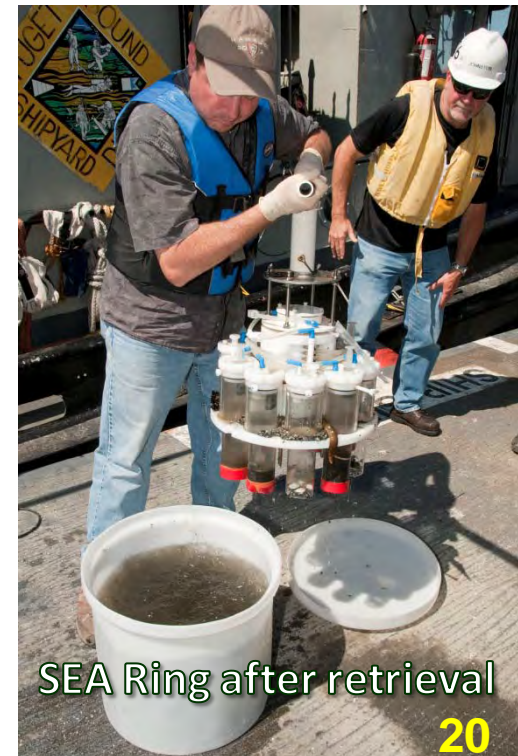
SEA Ring after retrieval

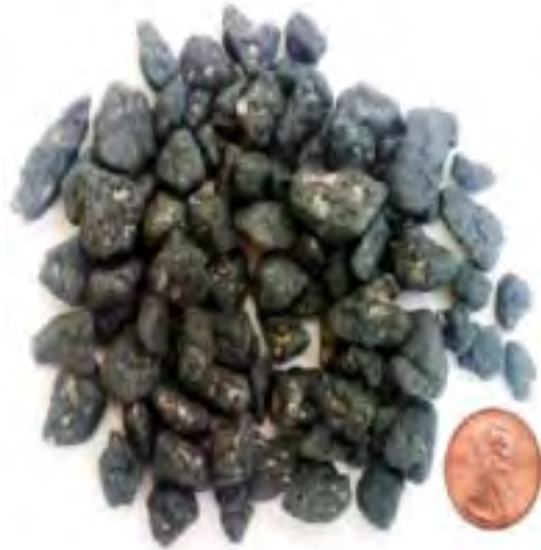
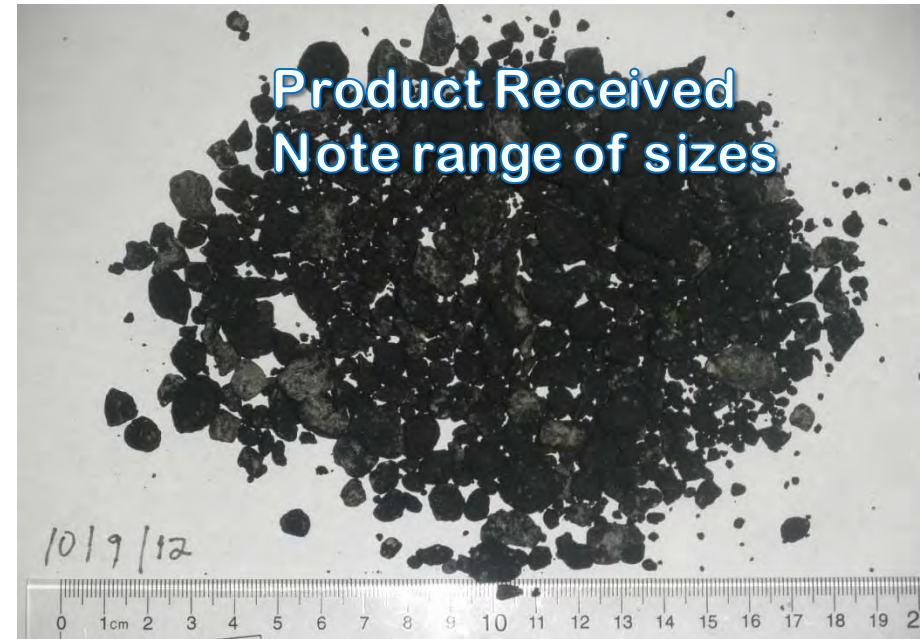
AquaGate+PAC™ Composite Aggregate

Product Received
Note range of sizes

Dry State – Pre-Placement

Coating Layer

Aggregate Core:
Average Size
1/4 - 3/8"

Post-Placement

After Placement – Powder Activated
Carbon Falls off Core and Mixes
Naturally with Sediment

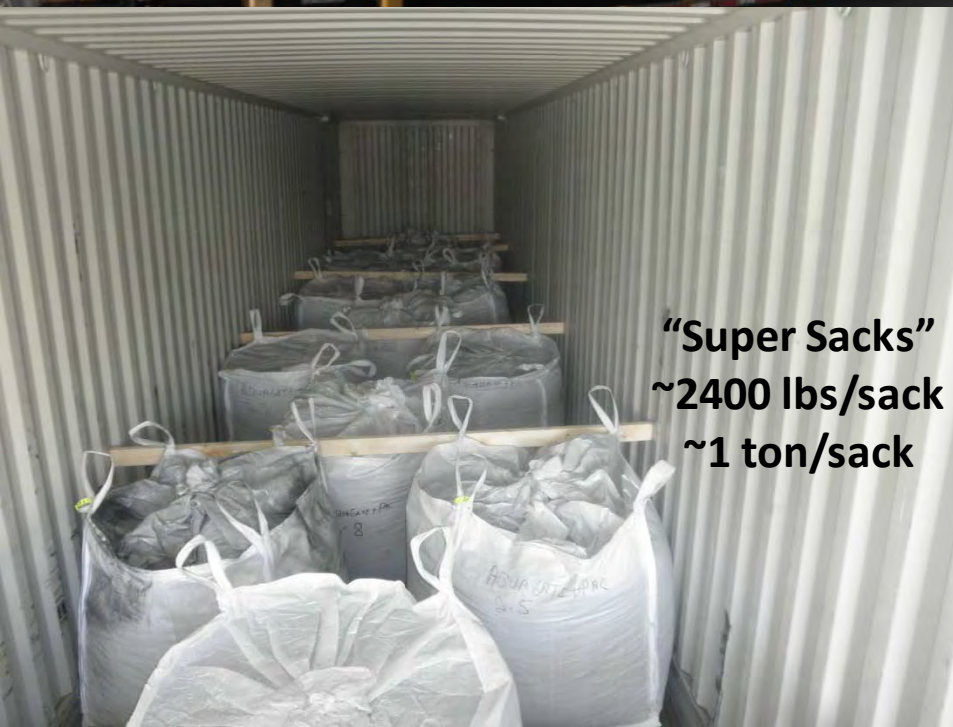
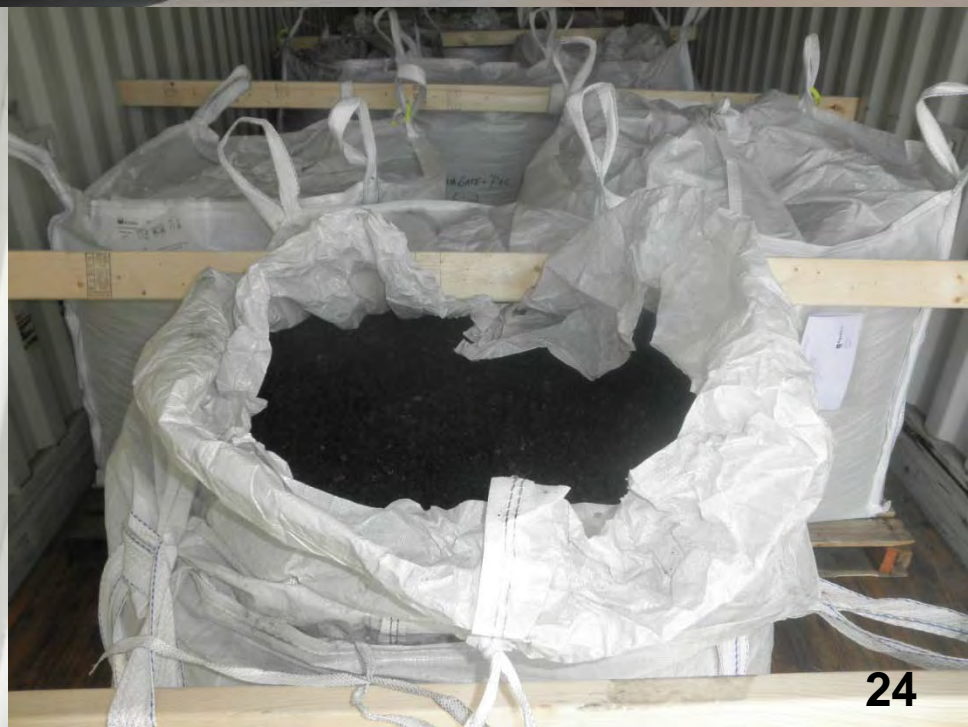
AquaGate Shipment to Port of Tacoma (Received 10/9/12)

“Super Sacks”
~2400 lbs/sack
~1 ton/sack

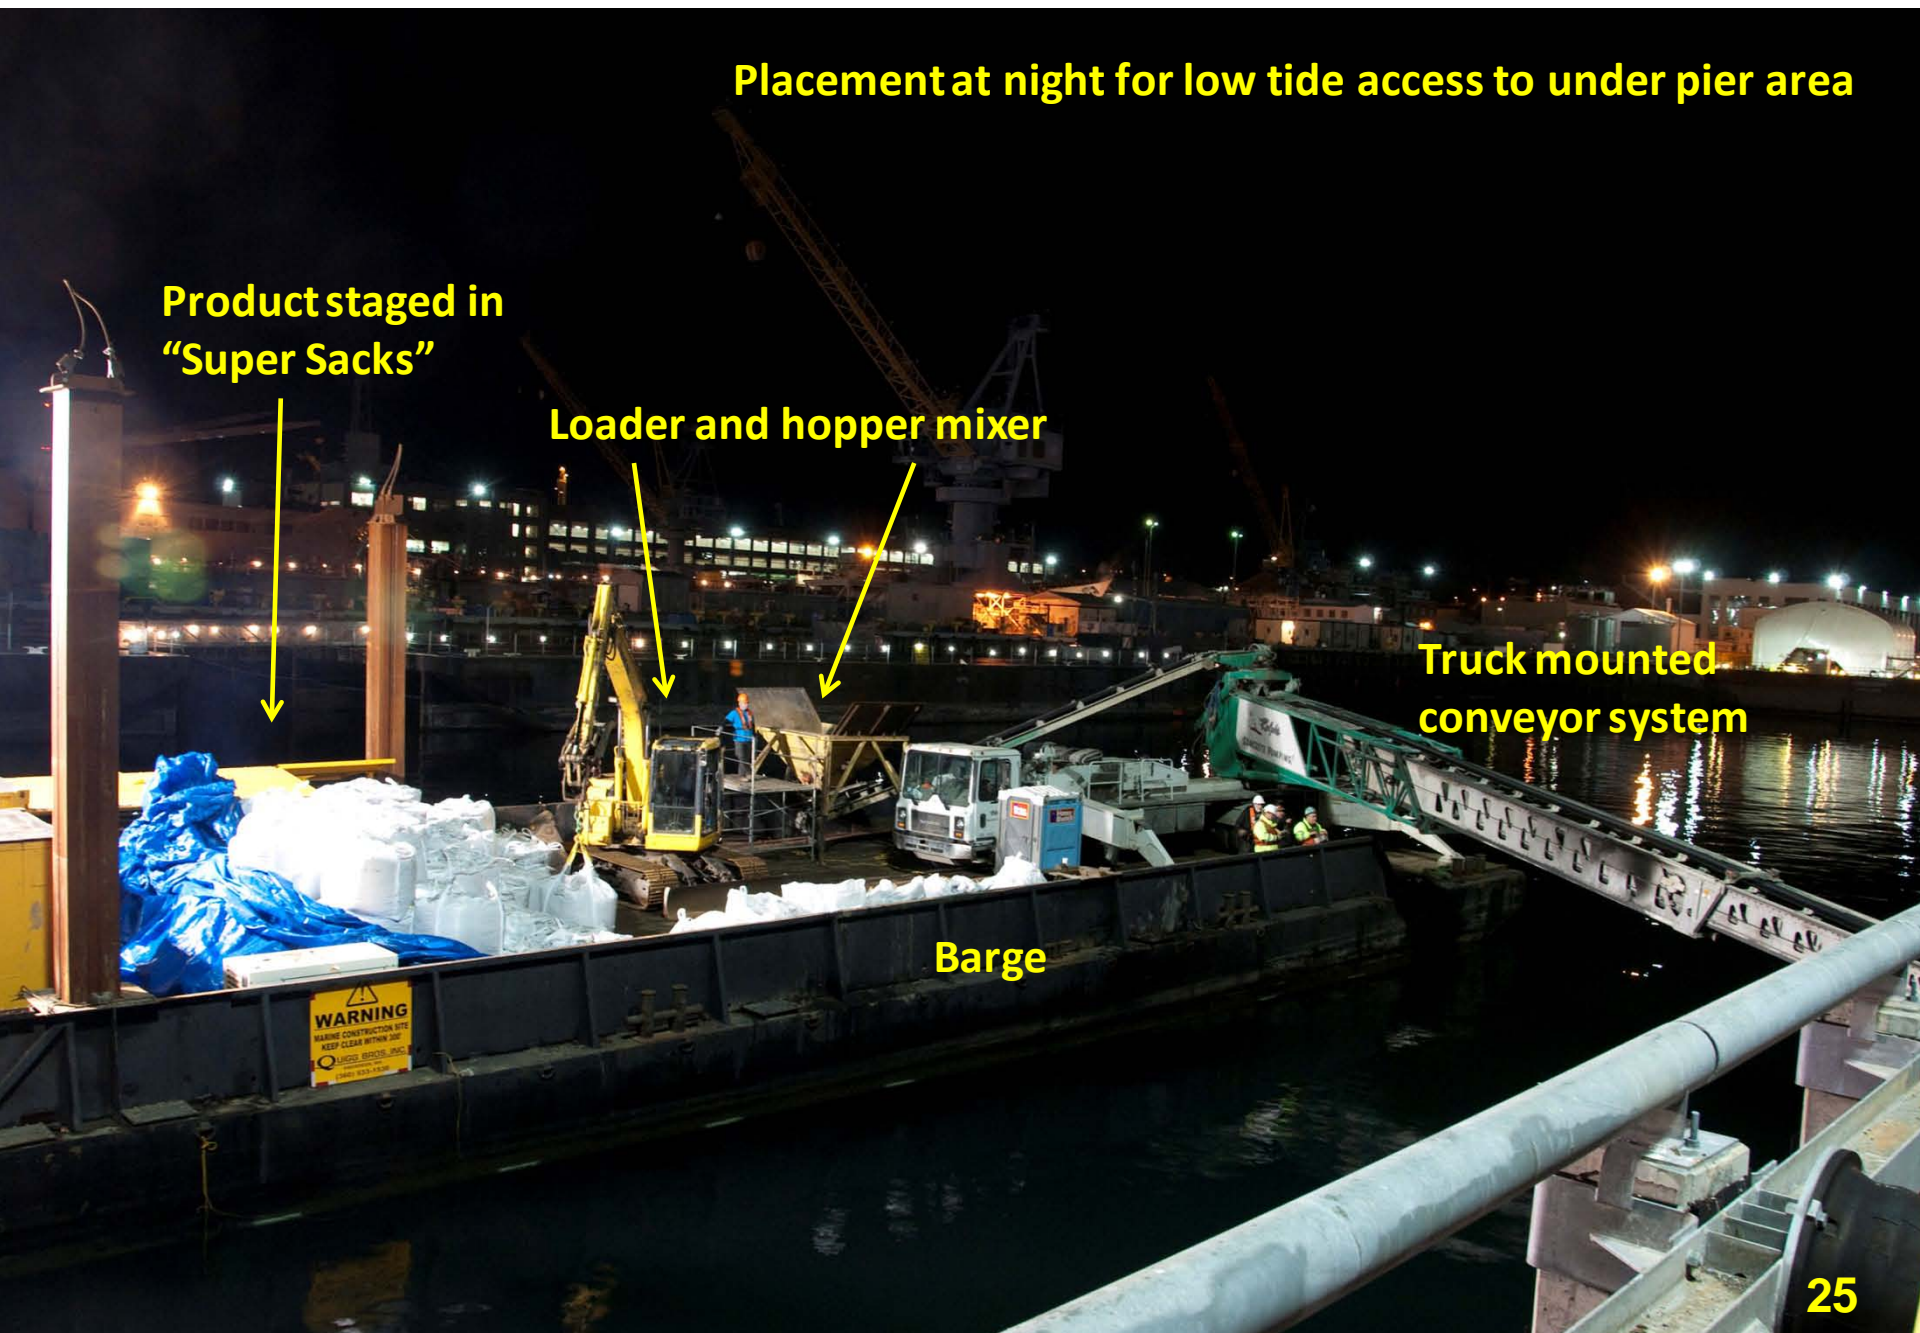
Product Staging and Placement

Placement at night for low tide access to under pier area

Product staged in
"Super Sacks"

Loader and hopper mixer

Truck mounted
conveyor system

Barge

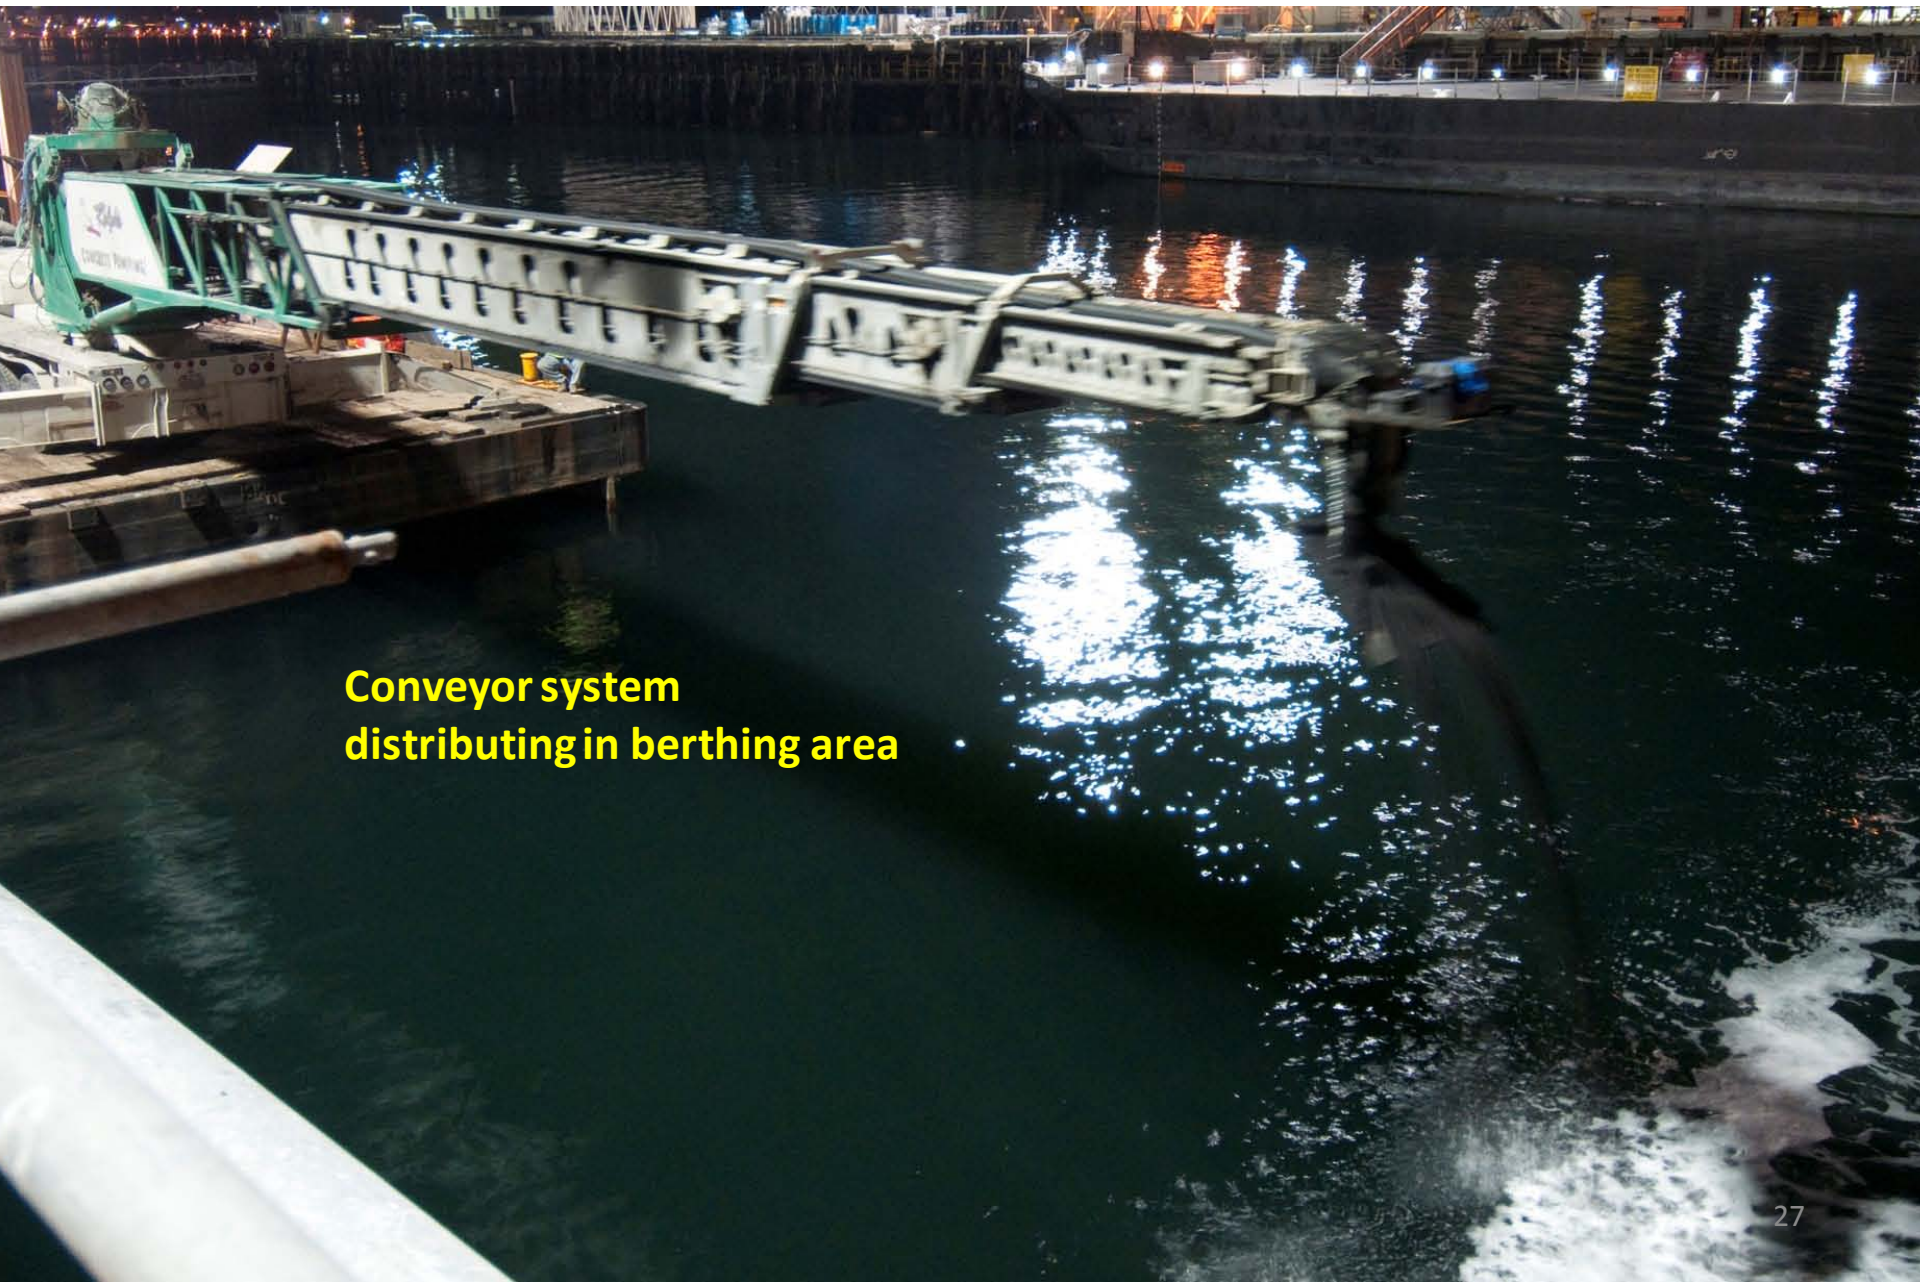
**Conveyor system
distributing in berthing area**

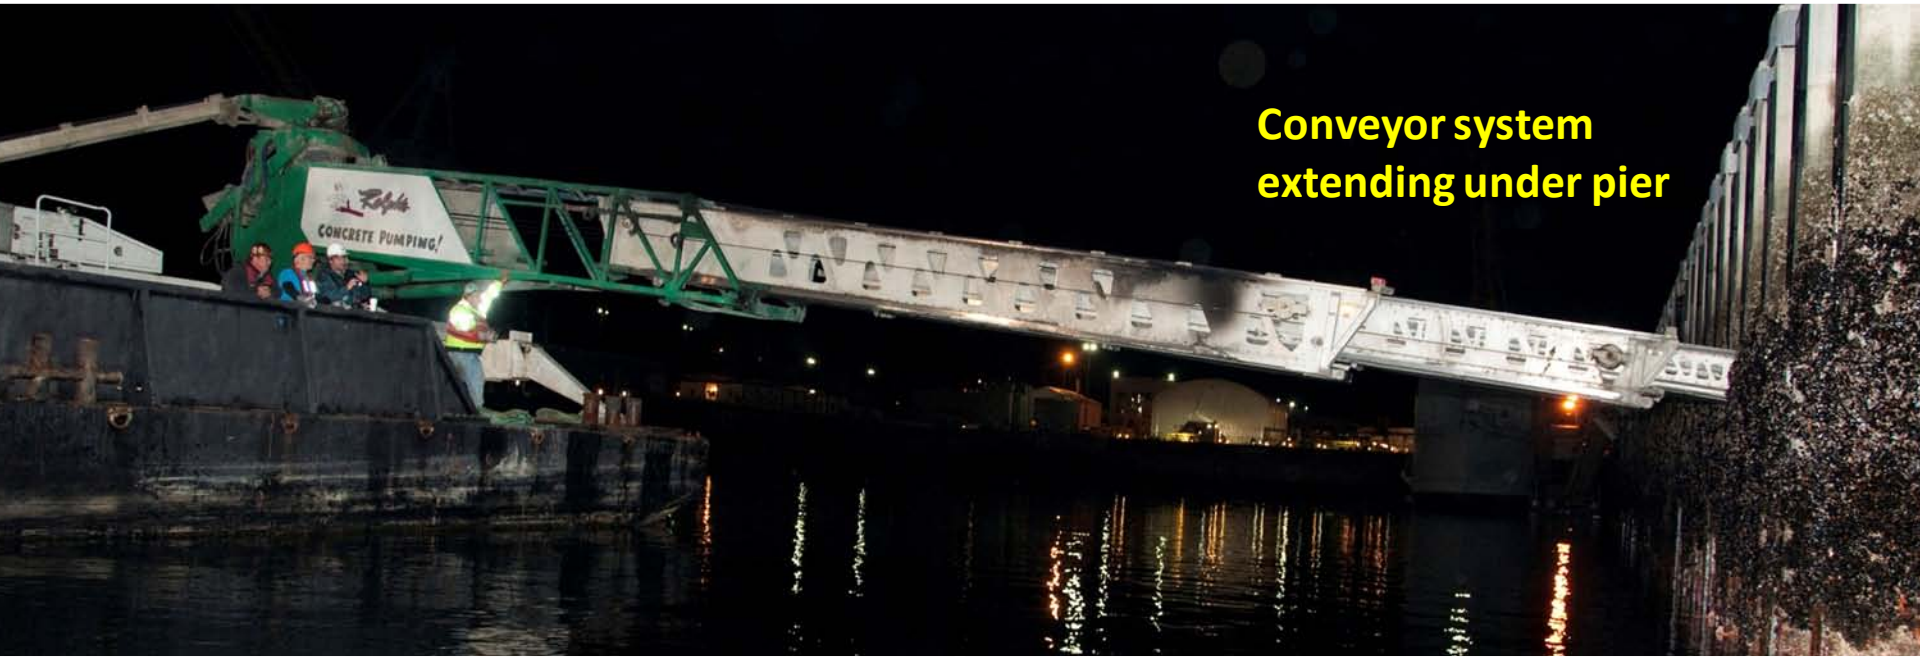
Conveyor system
extending under pier

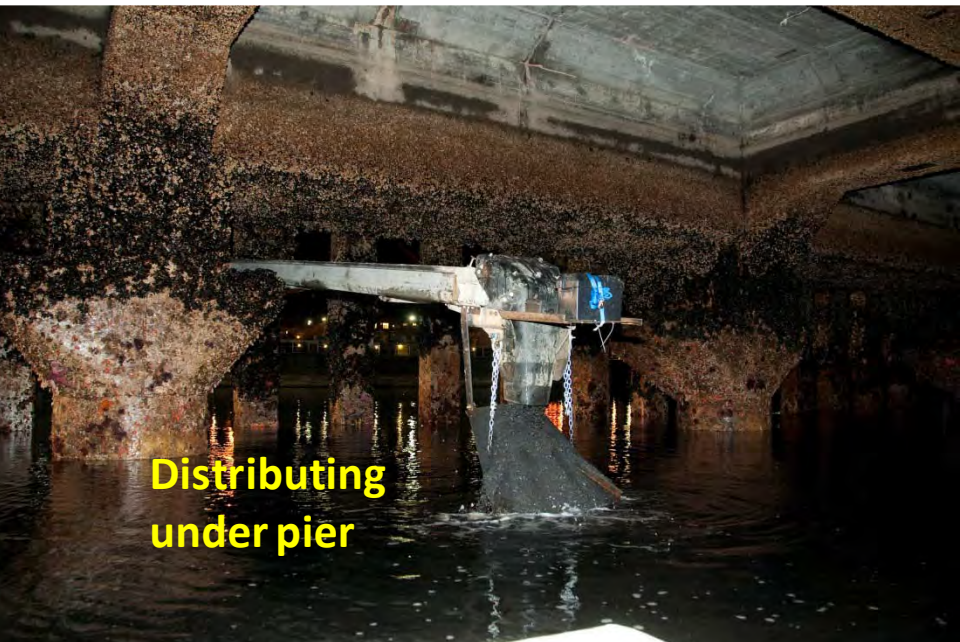
Distributing
under pier

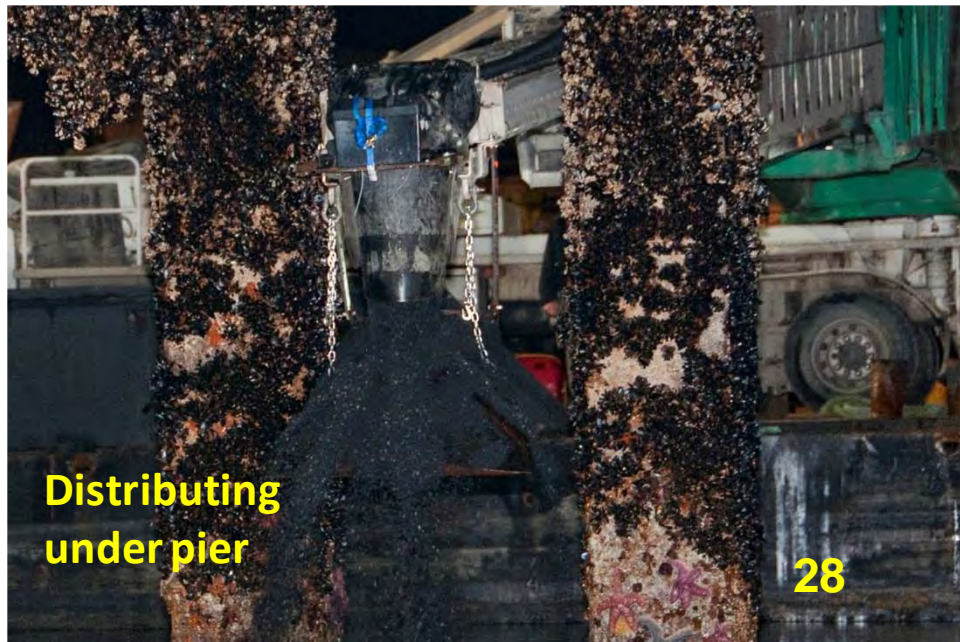
Distributing
under pier

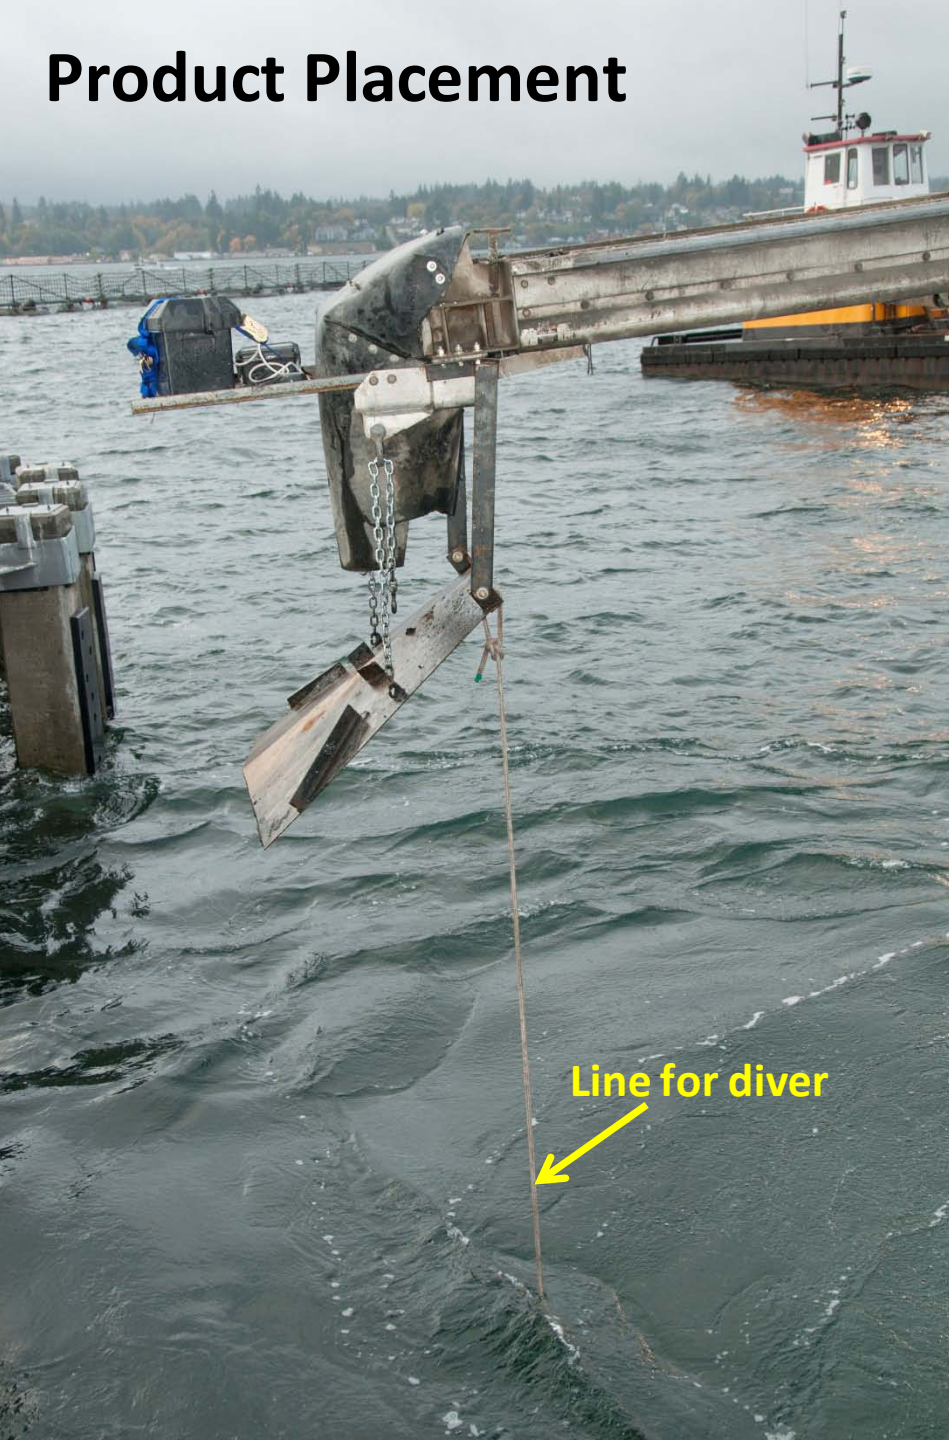
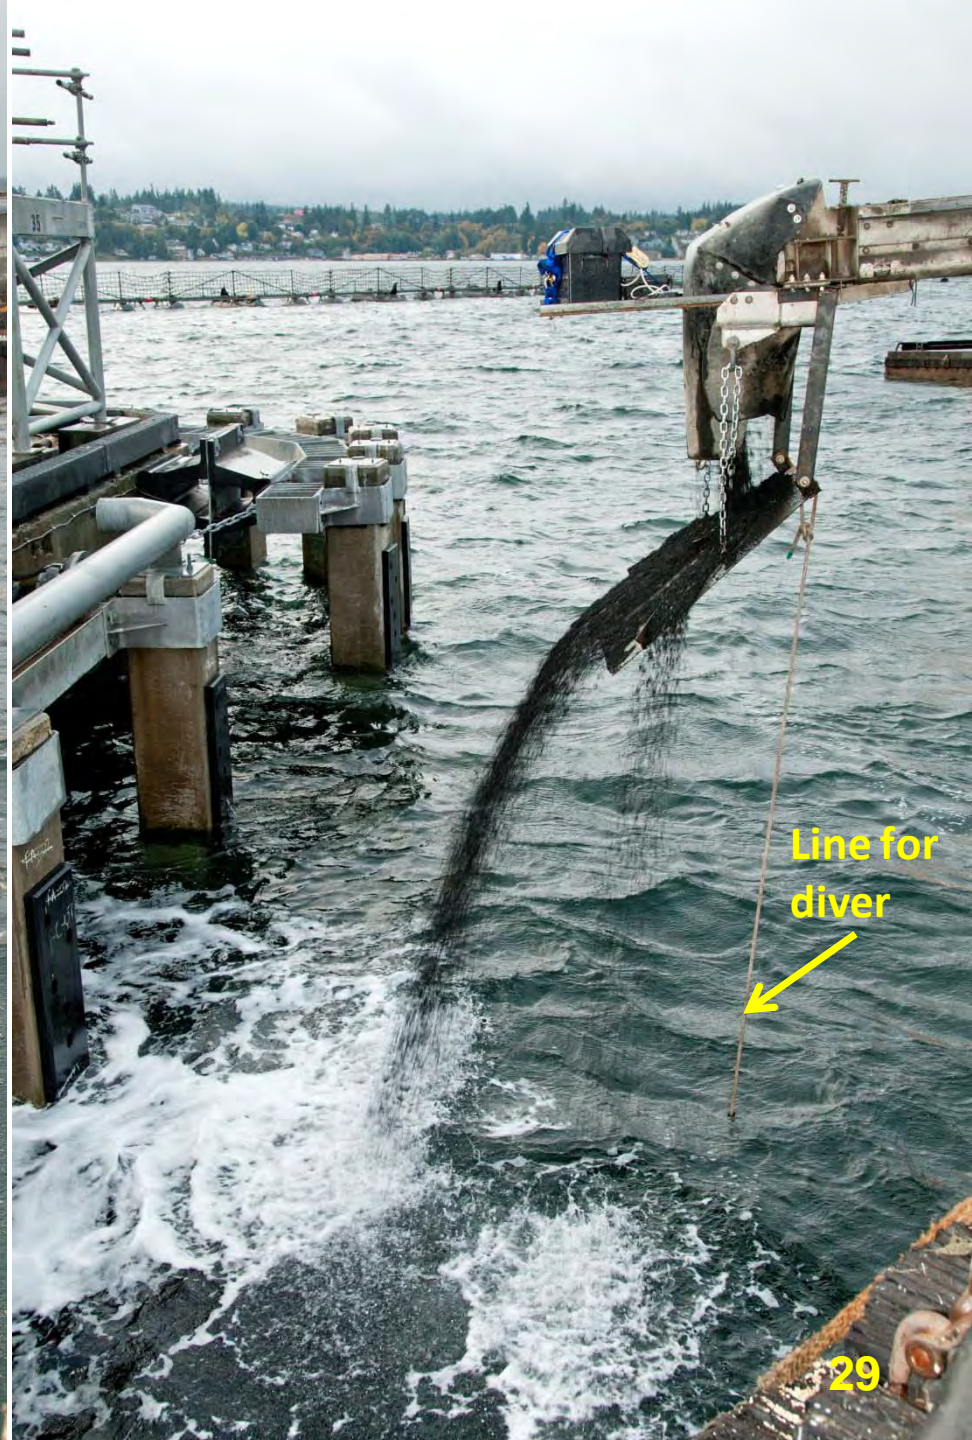
Water Column During Placement:

Diver in water column as product is released at the line

Diver follows product down

Diver watches product settle on the bottom

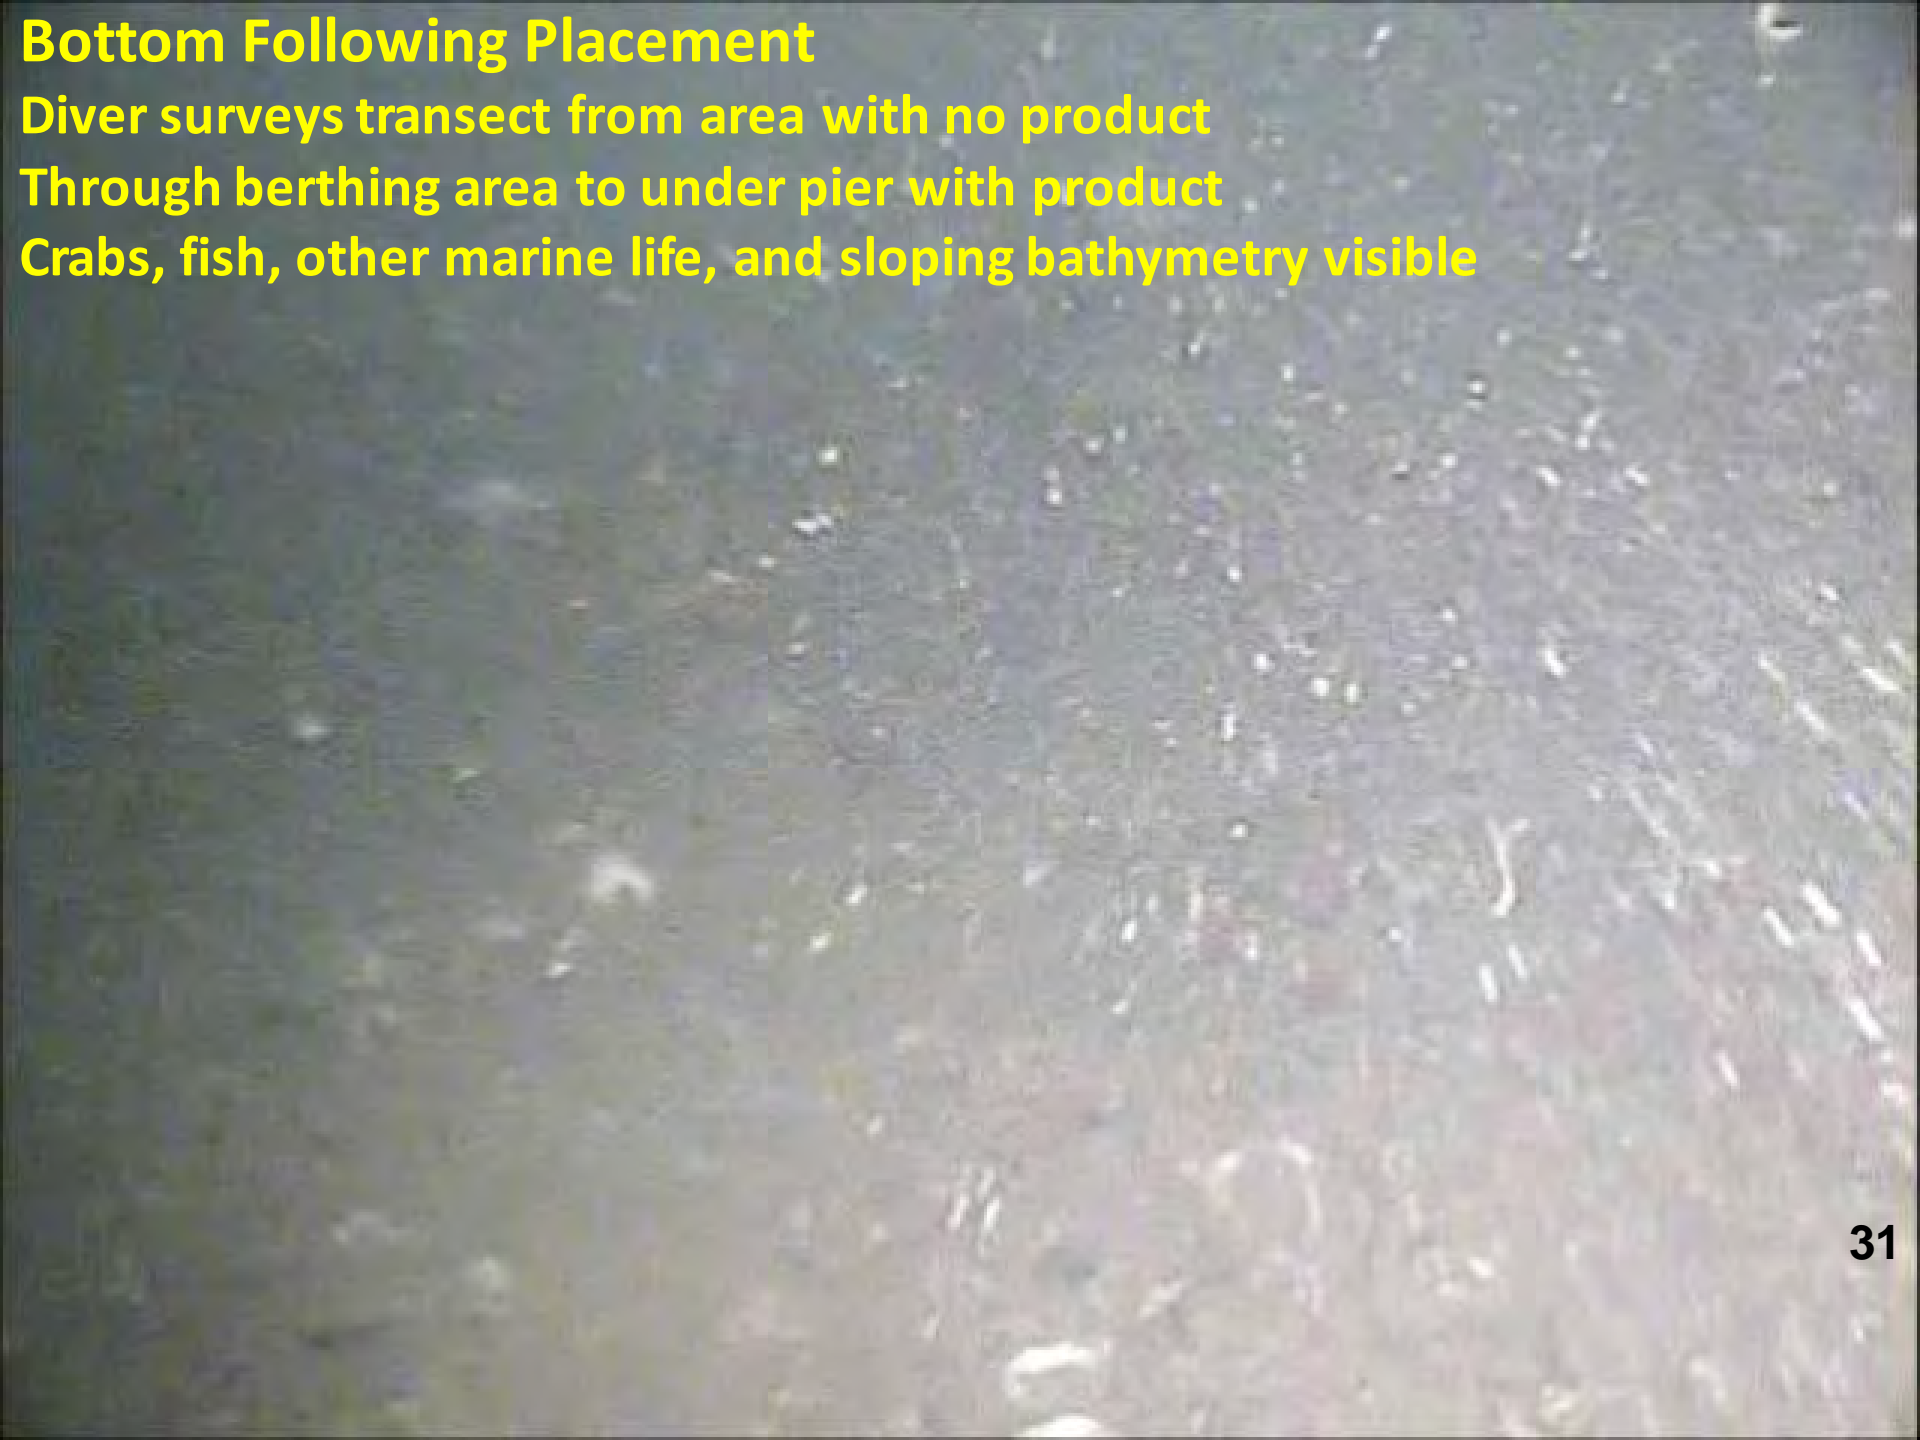
Bottom Following Placement

Diver surveys transect from area with no product

Through berthing area to under pier with product

Crabs, fish, other marine life, and sloping bathymetry visible

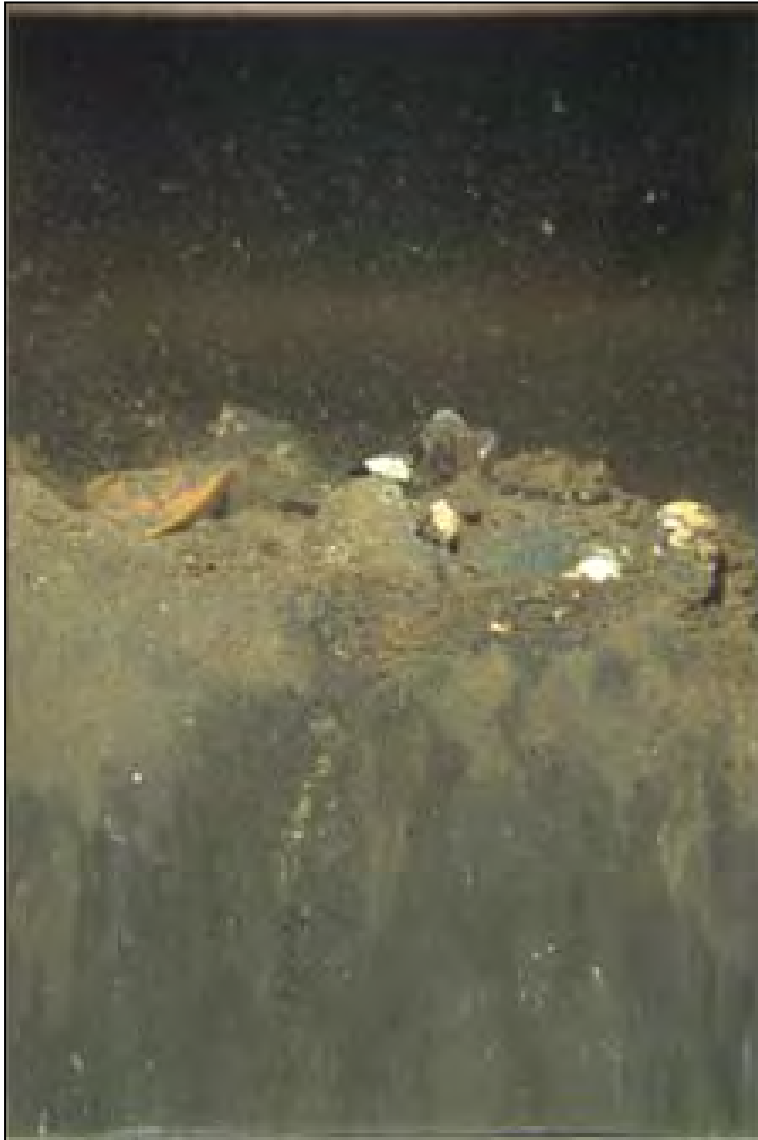
_DSC0101

Typical Sediment Profile from SPI camera

Before Placement

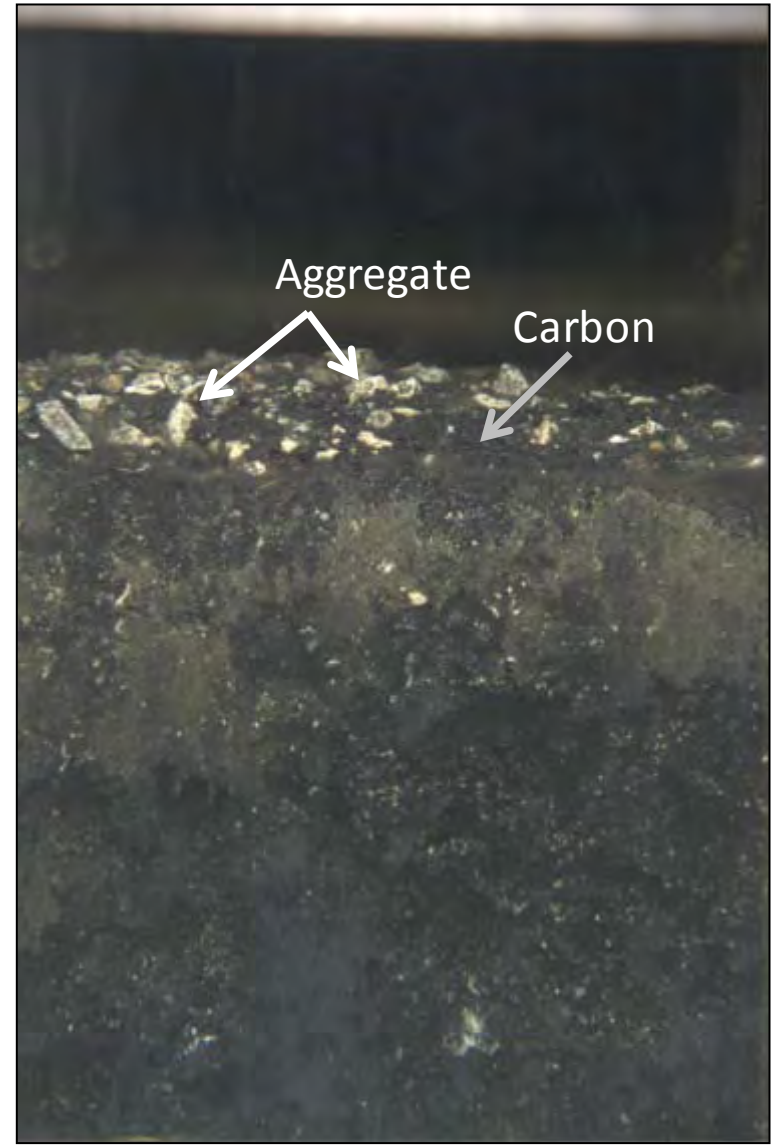
_DSC0225

After Placement
